# Report 5: Coastal Monitoring Gippsland Lakes Coastal Assessment

**August 2013**

Project Name	Gippsland Lakes Coastal Assessment
Client	Department of Environment and Primary Industries
Client Project Manager	Tania Brooker
Water Technology Project Manager	Warwick Bishop
Report Authors	Warwick Bishop, Tim Womersley
Job Number	2363-01
Report Number	R05
Document Name	2363-01R05v03a_Monitoring.docx

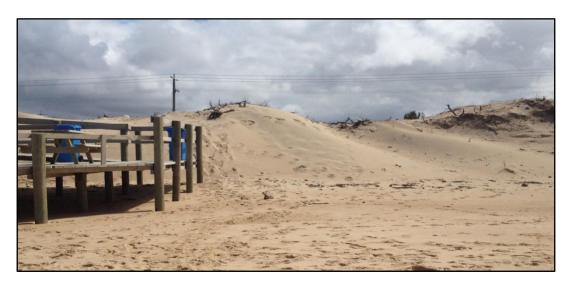
Figure 2-3 Western Seaspray Coastal Profile Location (15th October 2012)

The survey profile results are for Western Seaspray are plotted in Figure 2-2, with the survey startend coordinates provided in Table 2-1. Figure 2-3 shows a photo looking landward at the profile location. The results show there has been erosion of the dune crest and volume between 2007 and 2012.

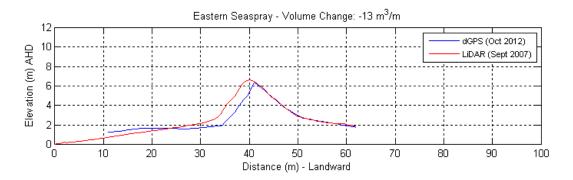
Figure 2-4 Eastern Seaspray Coastal Profile

The survey profile results are for Eastern Seaspray are plotted in Figure 2-4, with the survey startend coordinates provided in Table 2-2. Figure 2-5 shows a photo looking landward at the profile location. The results are very similar to Western Seaspray and show there has been erosion of the dune crest and volume between 2007 and 2012. Both the Seaspray profiles show good agreement with the LiDAR survey on the back-dune side, providing confidence in the accuracy of the measurements.

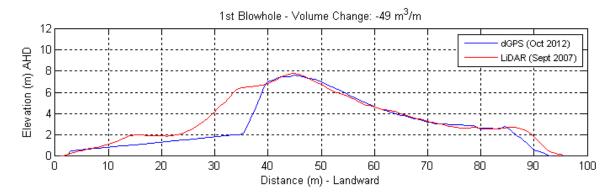
Figure 2-6 1<sup>st</sup> (western) Blowhole Coastal Profile

The survey profile results are for the First Blowhole are plotted in Figure 2-6, with the survey startend coordinates provided in Table 2-3. Figure 2-7 shows a photo looking landward at the profile location. The results show there has been significant erosion of the foredune and some erosion on the backface (lakeside) of the dune between 2007 and 2012. This is consistent with the photo image that shows clear dune cut and vegetation falling down the face of the dune.

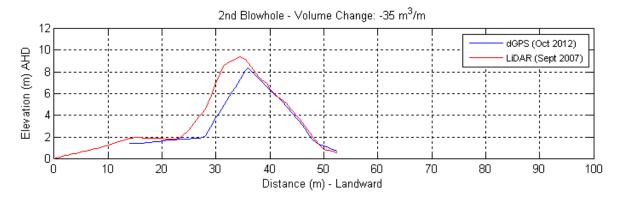
Figure 2-8 2<sup>nd</sup> (eastern) Blowhole Coastal Profile

The survey profile results are for the Second Blowhole are plotted in Figure 2-8, with the survey start-end coordinates provided in Table 2-4. Figure 2-9 shows a photo looking landward at the profile location. The results show there has been significant erosion of the foredune between 2007 and 2012. This is consistent with the photo image that shows clear dune cut and vegetation falling down the face of the dune.

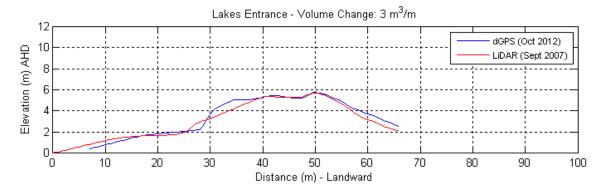
Figure 2-10 Lakes Entrance Coastal Profile

The survey profile results are for Eastern Beach are plotted in Figure 2-10, with the survey start-end coordinates provided in Table 2-5. Figure 2-11 shows a photo looking landward at the profile location. The results show there has been minimal change to the dune between 2007 and 2012, with only minor redistribution of sand on the foredune and some deposition on the back face.

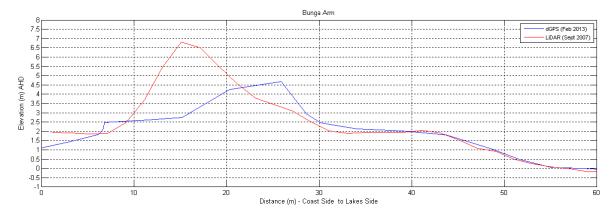
Figure 3-2 Bunga Arm Coastal Profile

The survey profile results are for Bunga Arm are plotted in Figure 3-3, with the survey start-end coordinates provided in Table 3-1. Figure 3-3 shows a photo looking landward at the profile location. The results show there has been minimal change to the lakeside part of the profile, whereas the main dune has eroded significantly and begun to translate to a more inland location between 2007 and 2013. The photo shows that dune vegetation has gone and subsequently a blowout formed.

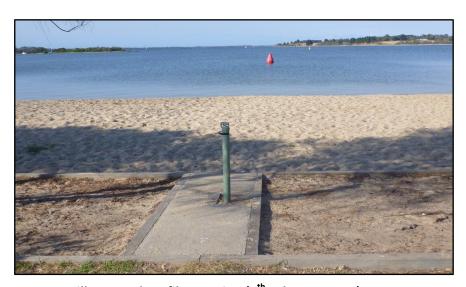
Figure 3-5 Paynesville Coastal Profile Location (4<sup>th</sup> February 2013)

The survey profile results are for Paynesville are plotted in Figure 3-4, with the survey start-end coordinates provided in Table 3-2. Figure 3-5 shows a photo looking seaward at the profile location. The results suggest there has been some loss of sand from near the lake shore between 2007 and 2013. However, this is inconclusive as the 2007 data may incorporate disturbance from the water surface.

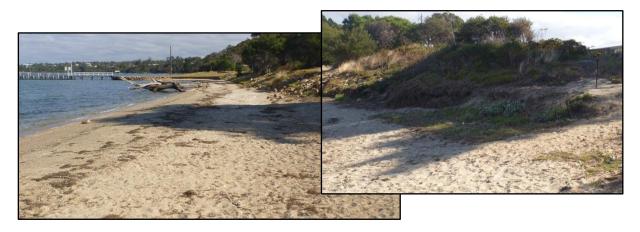
Figure 3-7 Metung Coastal Profile Location (4<sup>th</sup> February 2013)

The survey profile results are for Metung are plotted in Figure 3-6, with the survey start-end coordinates provided in Table 3-3. Figure 3-7 shows a photo looking north at the profile location. The results suggest there has been some cut into the rise behind the beach between 2007 and 2013. However, the shoreline appears to be stable, or to have recovered.

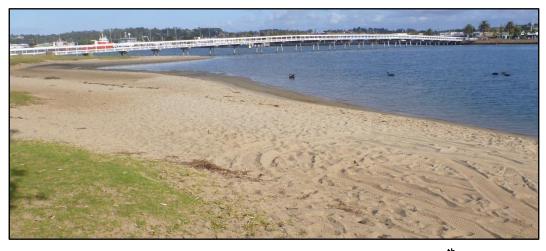
Figure 3-9 Lakes Entrance – Cunninghame Arm Coastal Profile Location (4<sup>th</sup> February 2013)

The survey profile results are for Lakes Entrance are plotted in Figure 3-8, with the survey start-end coordinates provided in Table 3-4. Figure 3-9 shows a photo looking west at the profile location. The results suggest there has been minimal change to the beach, with perhaps some accretion between 2007 and 2013.

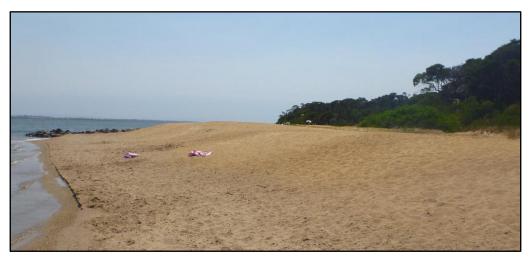
Figure 3-11 Loch Sport A Coastal Profile Location (4<sup>th</sup> February 2013)

The survey profile results are for Loch Sport A are plotted in Figure 3-10, with the survey start-end coordinates provided in Table 3-5. Figure 3-11 shows a photo looking east at the profile location. The results suggest there has been erosion from the upper sections of the profile and accretion in the lower sections between 2007 and 2013. Whilst not verified, it appears that the beach profile may have been recently altered due to artificial nourishment.

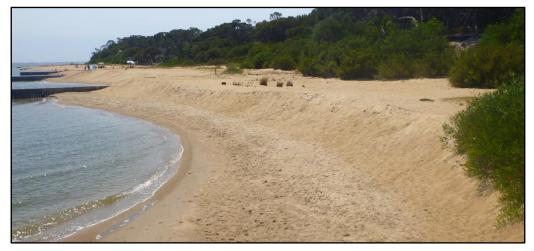
Figure 3-13 Loch Sport B Coastal Profile Location (4<sup>th</sup> February 2013)

The survey profile results are for Loch Sport B are plotted in Figure 3-12, with the survey start-end coordinates provided in Table 3-6. Figure 3-13 shows a photo looking east at the profile location. The results suggest there has been significant build-up of the profile between 2007 and 2013. Whilst not verified, it appears that the beach profile may have been altered due to artificial nourishment.
