# Report 5: Coastal Monitoring Gippsland Lakes Coastal Assessment

**August 2013**

Project Name	Gippsland Lakes Coastal Assessment
Client	Department of Environment and Primary Industries
Client Project Manager	Tania Brooker
Water Technology Project Manager	Warwick Bishop
Report Authors	Warwick Bishop, Tim Womersley
Job Number	2363-01
Report Number	R05
Document Name	2363-01R05v03a_Monitoring.docx

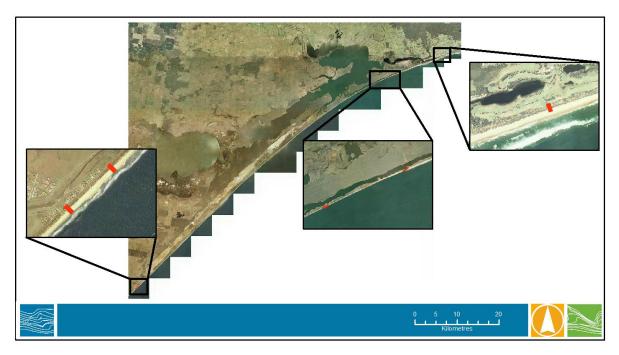
Figure 2-1 Ninety Mile Beach Coastal Profile Survey Locations

Coastal profiles have been surveyed along the <sup>1</sup>Ninety Mile Beach as to enable monitoring and assessment of ongoing coastal profile change to be undertaken. A total of 5 coastal profiles have been surveyed. The locations for undertaking the coastal profiles were identified through analysis of the outer barrier dune profiles from the LiDAR dataset to identify sections of the barrier with the lowest volumes and therefore increased potential vulnerability to erosion. The coastal profile locations were also cross-checked against other geomorphic and historical evidence of significant coastal change along the Ninety Mile Beach. The five locations selected for coastal profile surveying are displayed in Figure 2-1 and detailed below:

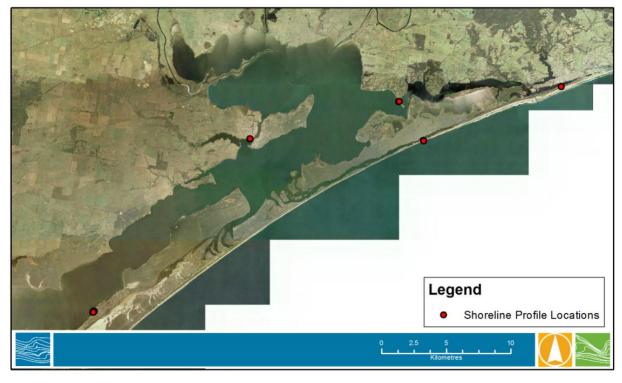
Figure 3-1 Lakes Shoreline Profile Locations

Lake-side shoreline profiles were surveyed at various locations around the Gippsland Lakes to enable monitoring and assessment of ongoing shoreline position and profile change to be undertaken. A total of six profiles were surveyed, on the 3rd and 4th of February 2013, at the locations shown in Figure 3-1Error! Reference source not found. Some additional profiles were captured the previous week, however the data for these was unfortunately lost due to a rare equipment failure.
